Manhole Inspection Summary

Manhole # S29CC2001MH

Insp Date: **12/4/06 9:41 AM**

Location Address: **1 SAINT GEORGES RD**

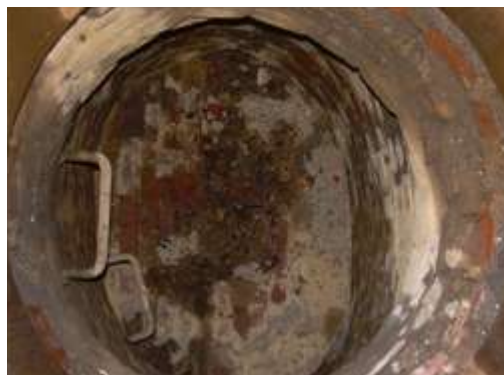
Top View

Channel debris.

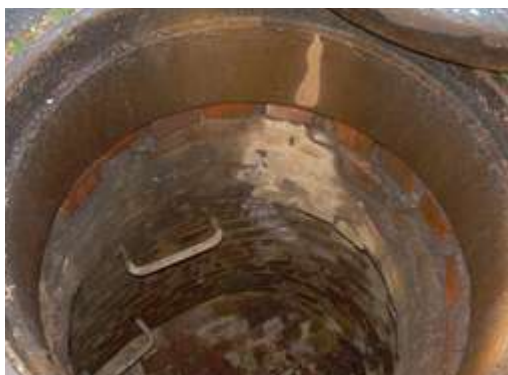
Defect

Frame leaks. Adjustment deterioration and infiltration. Corbel and Barrel infiltration - other side.

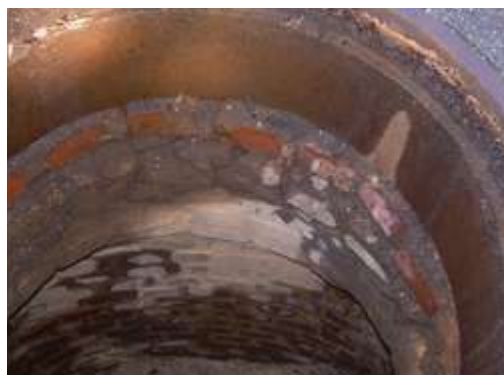
Defect

Frame leaks. Adjustment deterioration and infiltration. Corbel and Barrel infiltration.

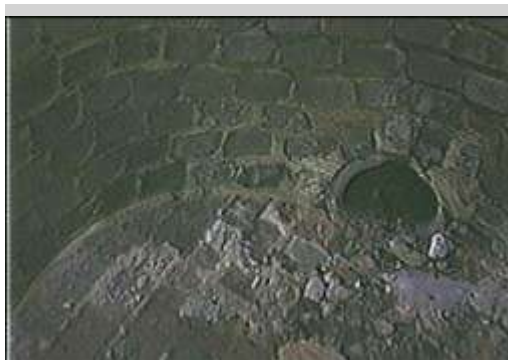
Defect

Barrel deterioration and infiltration.

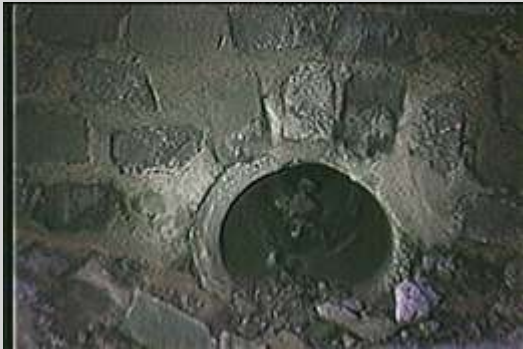
8 in. Circular Gravity Sewer
Pipe Out @ 12 O'Clock

Deposits: ☐ None ☐ Mud ☐ Sludge ☒ **Debris** ☐ Grease

Silt Depth: **2** (in.) Deposits Extent: **Light**
